NASA Engineering and Safety Center Technical Assessment Report	Version: 1.0
Title:	National Highway Traffic Safety Administration Toyota Unintended Acceleration Investigation	Page #: 1 of 177

**Technical Support to the National Highway Traffic Safety
Administration (NHTSA) on the Reported Toyota Motor
Corporation (TMC) Unintended Acceleration (UA)
Investigation**

January 18, 2011

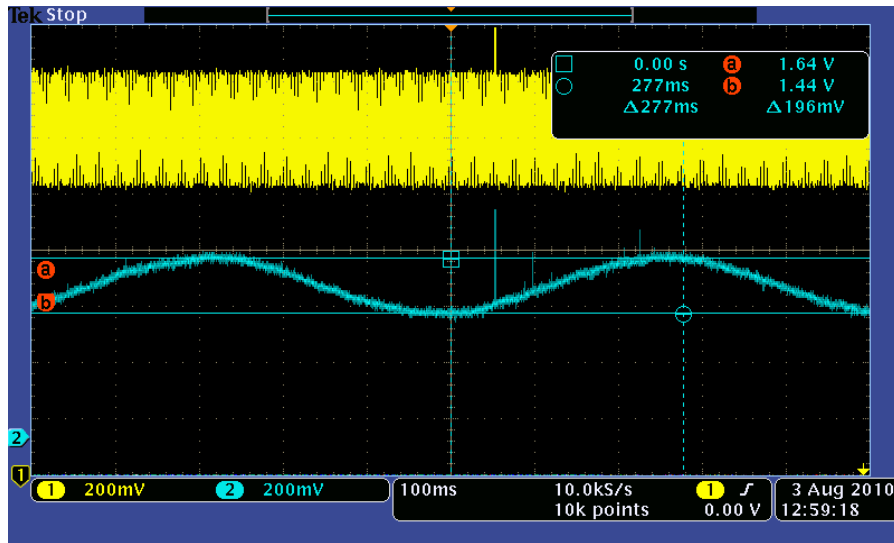
Figure 6.6.1.2-3. 500Hz injected common to both VPA signals (top Yellow trace) results in driving the motor and roughly 2 Hz aliasing sensed on VTA (bottom Blue trace)

Figure 6.6.1.2-2 indicates the postulated EMI faults as identified from the fishbone analysis. Three different tests uncovered a 500 Hz sensitivity; the noise injection common to both VPA signals, noise injection on VTA1 signal, and the vehicle level conductive EMC testing.

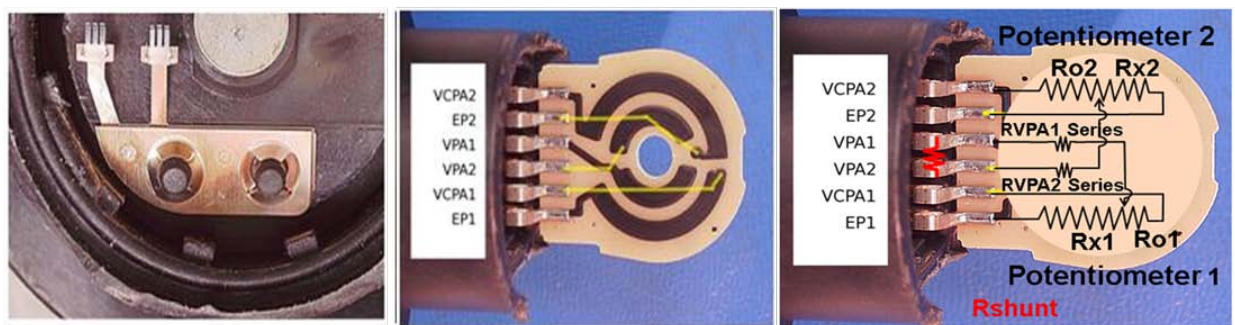
Figure 6.6.2.3-1. One of two rotating contact assemblies (left), resistive elements (center), and electrical diagram (right) for the potentiometer pedal sensors showing defective accelerator pedal assembly fault region

Vehicle testing using a defective potentiometer accelerator pedal assembly from a VOQ vehicle with a resistive short, within a narrow range of values between the sensors outputs, identified a vulnerability that may compromise nominal limp home mode fail-safe operation on subsequent ignition key cycles and affect the malfunction indicator lamp (MIL) display and/or DTC generation under certain specific conditions.

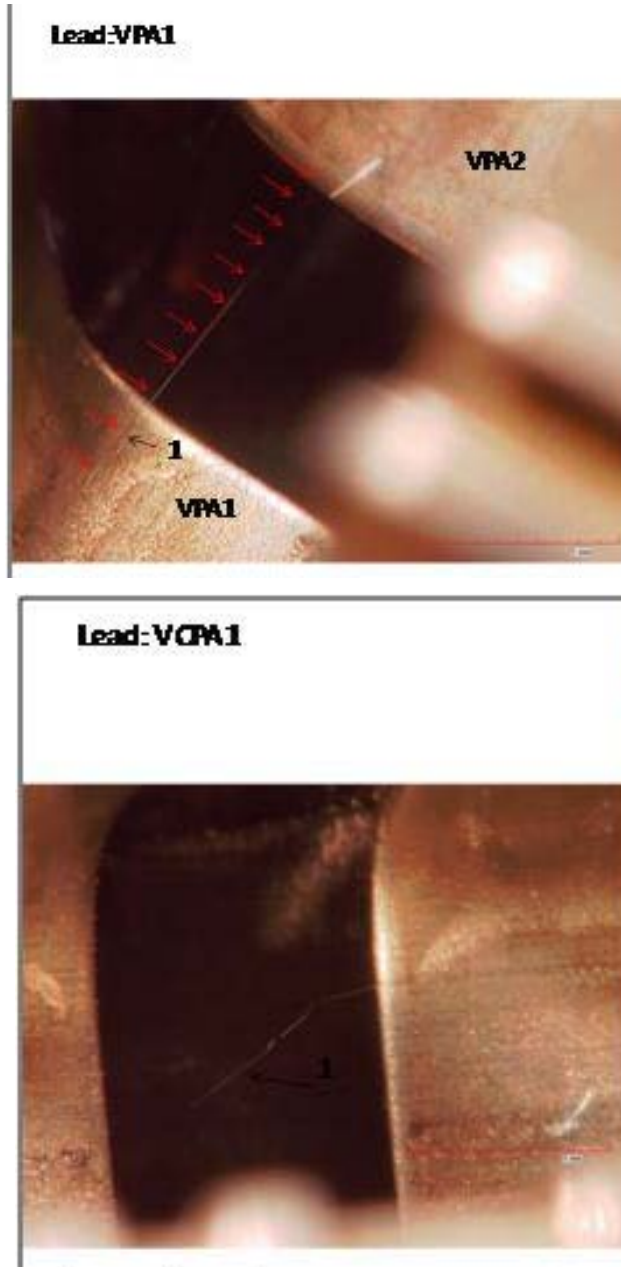
Figure 6.6.2.3-6. Shorting whisker VPA1 to VPA2 (top) and long whisker on VCPA1 (bottom)

Destructive physical analysis of this pedal assembly found tin whiskers², one of which had formed the resistive partial short circuit between the pedal signal outputs. A second tin whisker of similar length was also found in this pedal assembly that had not caused an electrical short. If a resistive short between the potentiometer accelerator pedal signal outputs exists, the system may be vulnerable to a specific second fault condition that could theoretically lead to UA. However, if resistive faults were occurring during normal use, DTCs would be expected from at least the first ignition key cycle and the following cycles that did not meet the specific criteria. Subsequent review of the warranty data does not support an observable failure signature of pedal-induced DTCs. Electrical measurements on six VOQ vehicles found no indication of the resistive paths necessary for this failure scenario.
